# Manhole Inspection Summary

Manhole # S63G\_\_031MH

**Location** Address: **5401 Mason Lord Dr.**

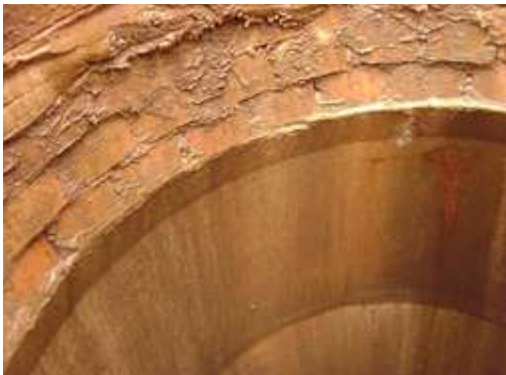
Defect 3

infiltration

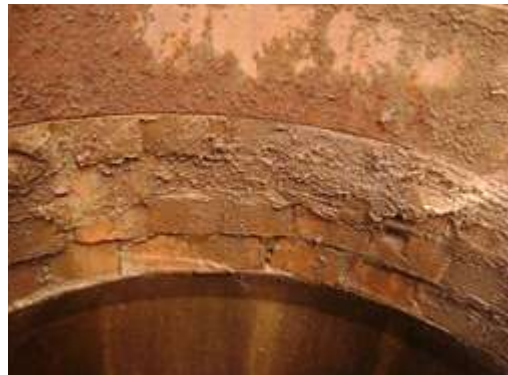
Defect 2

minerals encrusted

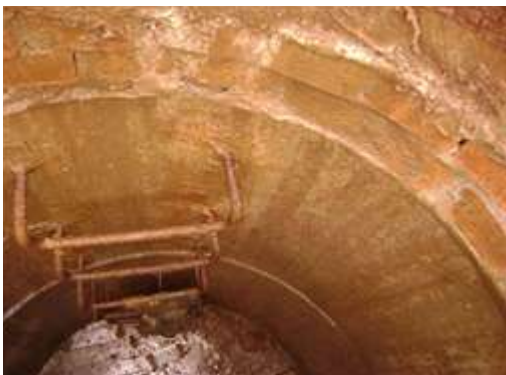
Defect 1

Infiltration: ☐ None ☐ Joint ☐ Cracks ☐ Mortar ☐ Roots ☒ **Wall**

infiltration on barrel walls

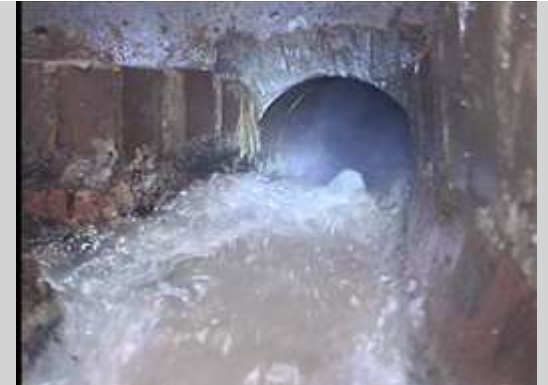
12 O'Clock Outflow

Pipe Height: **8.4** (in.) Rod and Bar (Angled)  
Pipe Material: **Clay** ☐ Pipe Lined  
Invert Depth: **8.08** (ft.) Flow Characteristics: **Turbulent**  
Deposits: ☒ None ☐ Mud ☐ Sludge ☐ Debris ☐ Grease  
Silt Depth: (in.) Deposits Extent:  
Infiltration: **None** Pipe Seal Cond: **Sound**

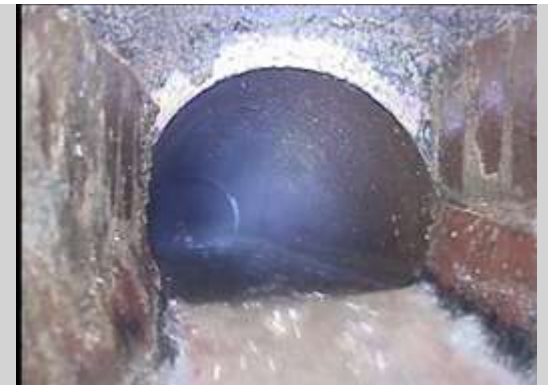
6 O'Clock Inflow

Pipe Height: **8.4** (in.) Rod and Bar (Angled)  
Pipe Material: **Clay** ☐ Pipe Lined  
Invert Depth: **8.00** (ft.) Flow Characteristics: **Fast**  
Deposits: ☒ None ☐ Mud ☐ Sludge ☐ Debris ☐ Grease  
Silt Depth: (in.) Deposits Extent:  
Infiltration: **None** Pipe Seal Cond: **Sound**

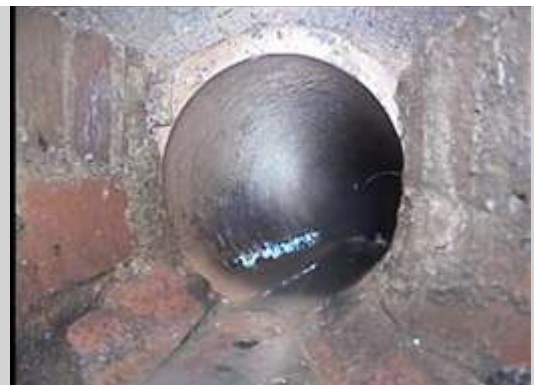
9 O'Clock Inflow

Invert Depth: **8.00** (ft.) Flow Characteristics: **Slow**

Infiltration: **None**

Pipe Seal Cond: **Sound**
